Facility Condition Assessment

East Providence - East Providence High School

June 2017

2000 Pawtucket Avenue, East Providence, RI 02914

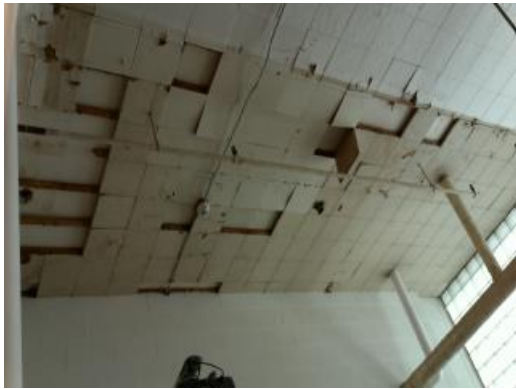
Failing Ceiling Tiles

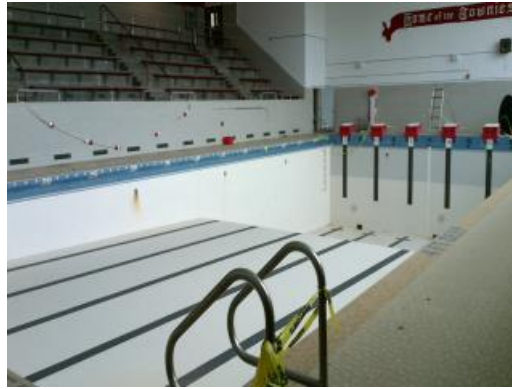
Abandoned Pool

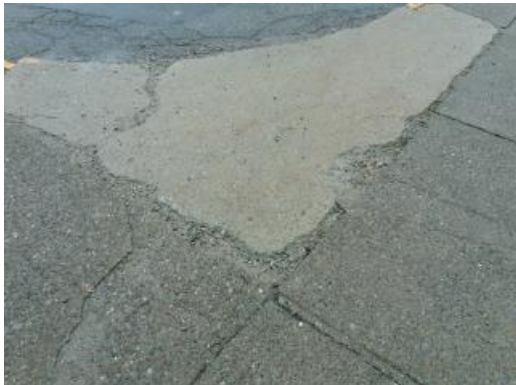
Damaged Concrete Walkways

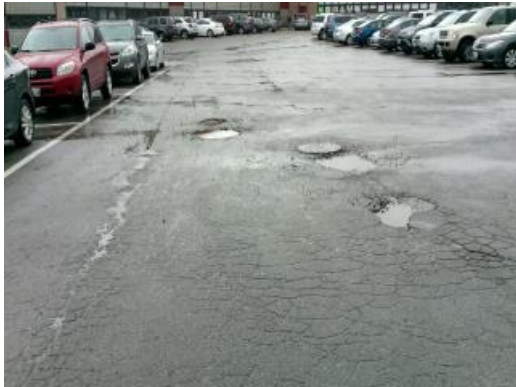
Pot Holes And Alligating

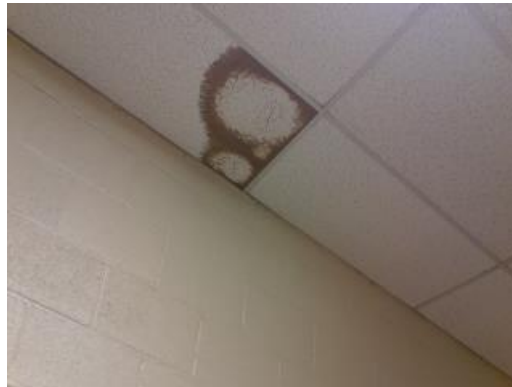
Stained Ceiling Tile

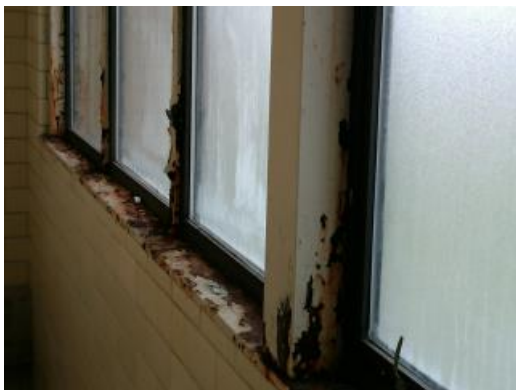
Corroded Steel Windows

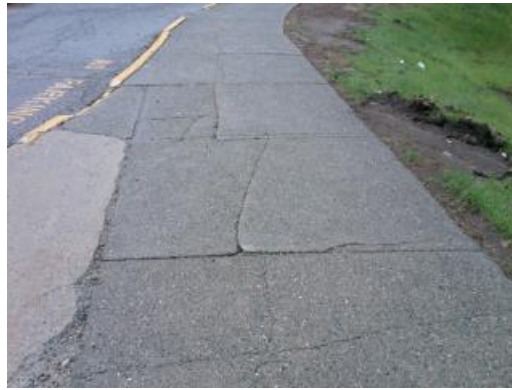
Cracked Concrete Walkway

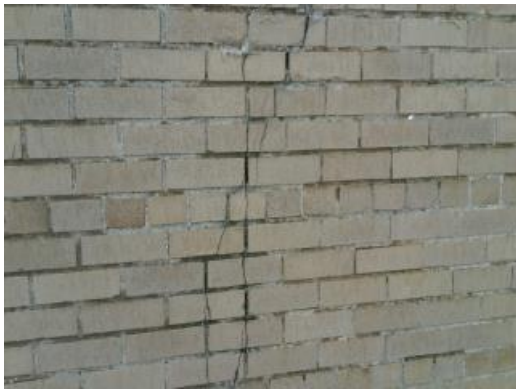
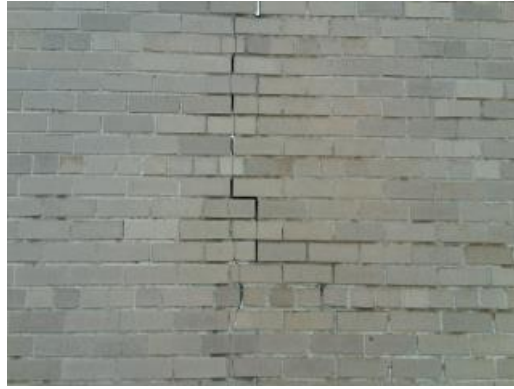
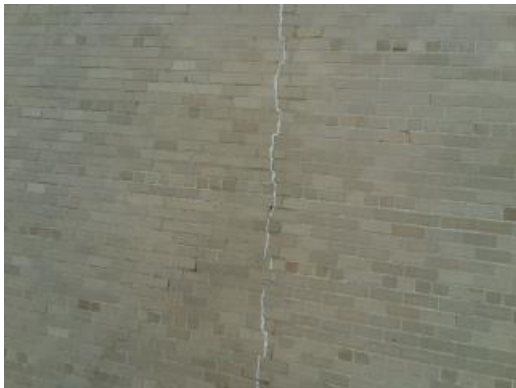
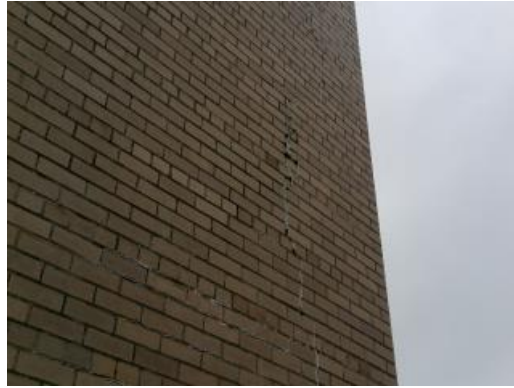
Note: Exterior brick is cracked and should be repaired.						
The Brick Exterior Requires Repointing	Capital Renewal	7,500	SF Wall	3	\$330,784	11132
Sub Total for System		9 items			\$2,987,735

Cracked Exterior Brick

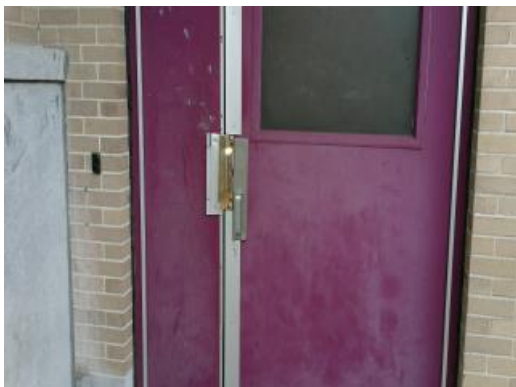
Worn Exterior Door

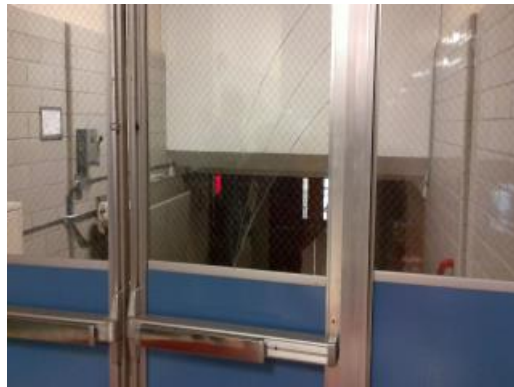
Damaged Storefront Door

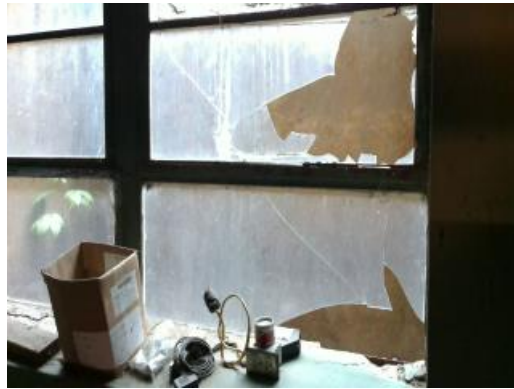
Broken Basement Windows

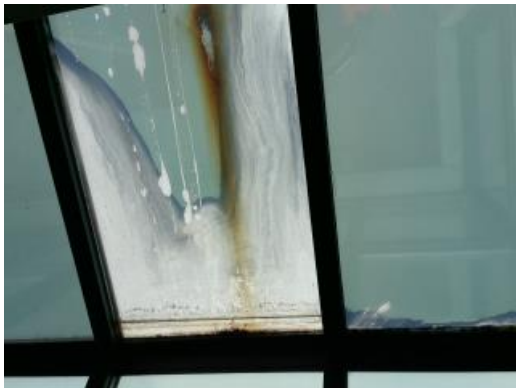
Damaged Window

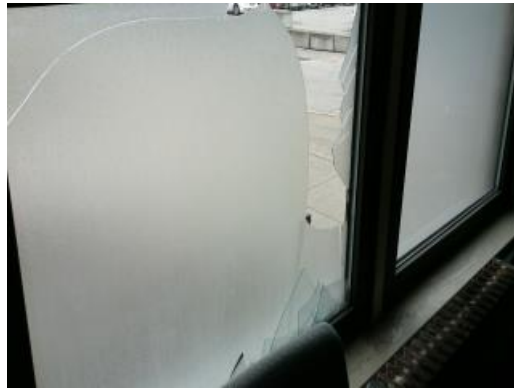
Broken Window

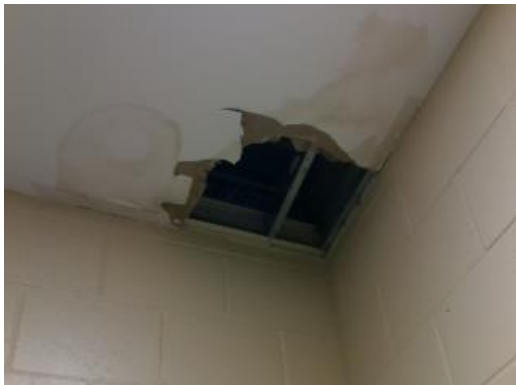
Hole in Ceiling

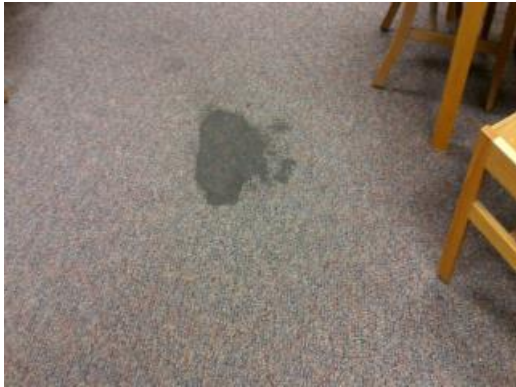
Stained And Worn Carpet

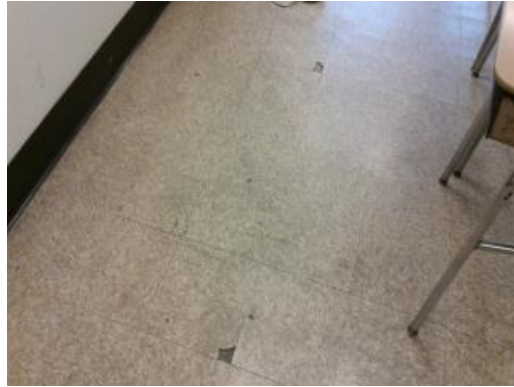
Chipped VCT

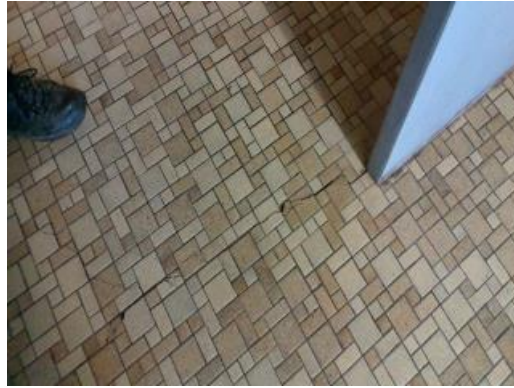
The Ceramic Tile Flooring Requires Replacement	Capital Renewal	10,808	SF	3	\$306,012	11116
Note: Original ceramic flooring should be replaced.						
Location: 1952 wing						
The Vinyl Composition Tile Requires Replacement	Capital Renewal	500	SF	3	\$6,048	11115
Location: 1999 corridors, 3rd floor band area offices						
The Vinyl Composition Tile Requires Replacement	Capital Renewal	5,395	SF	3	\$65,254	53563
Note: Per LEA review feedback cafeteria floor (transition old to new) must be replaced.						
Acoustical Wall Panels Require Replacement	Capital Renewal	250,000	SF	4	\$2,420,736	11164
Note: Tiles are broken and falling from walls.						
Asbestos 9x9 Tile is Present. Limited Areas of Lifting or Broken Tiles Exist	Hazardous Material	100	SF	4	\$3,007	Rollup

Cracked Ceramic Floor

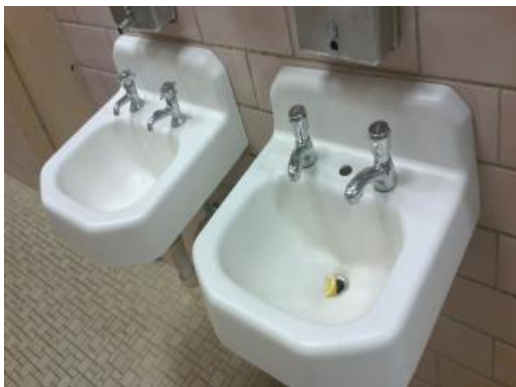
Aged And Stained Restroom Lavatories

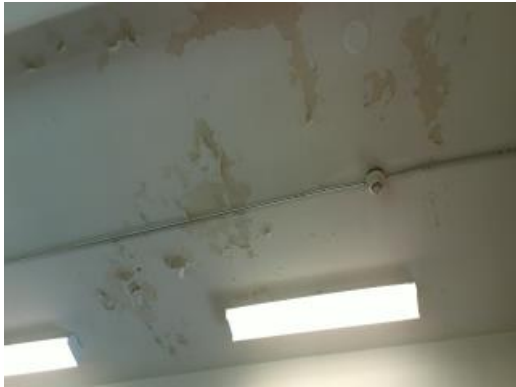
Peeling Ceiling Paint

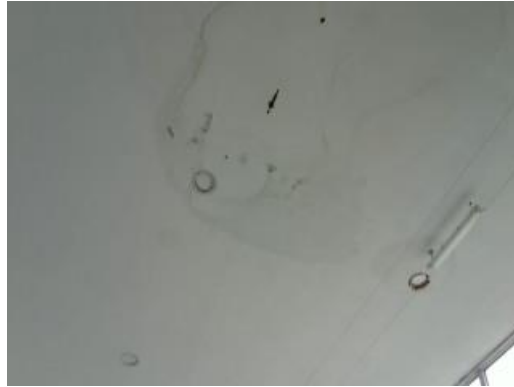
Stained Ceiling

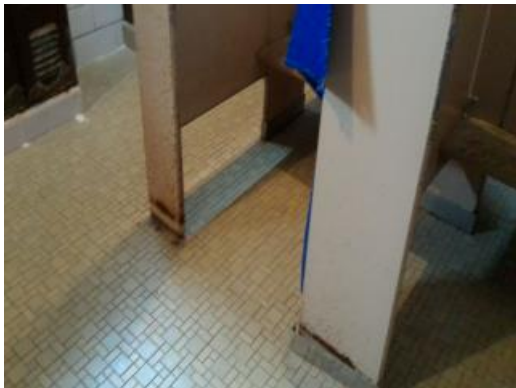
Damaged Toilet Partitions

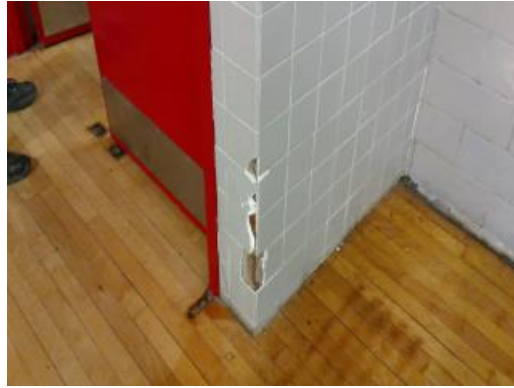
Chipped Tile Wall

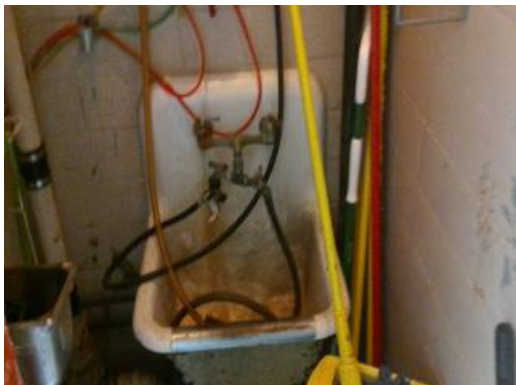
Corroded Service Sink

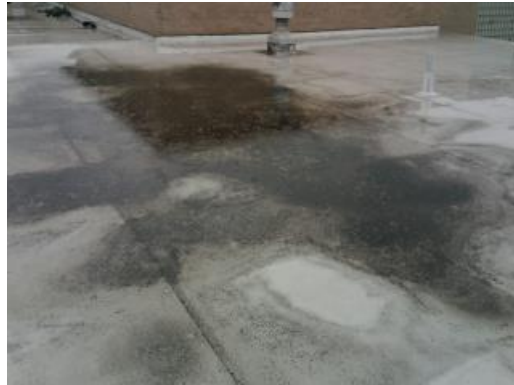
Ponding On Roof

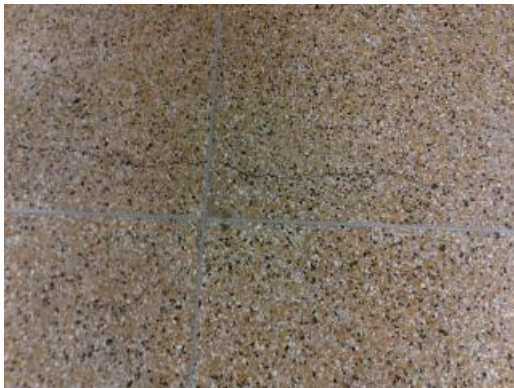
Cracked Terrazzo

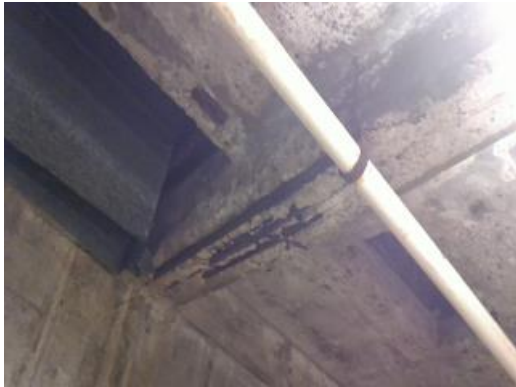
Moderate Structural Condition Exists	Capital Renewal	1	Job	1	\$100,238	11139
Note: Corridor under pool, walls and deck are shifting.						
Sub Total for System		2 items			\$332,789

Damaged Concrete Deck

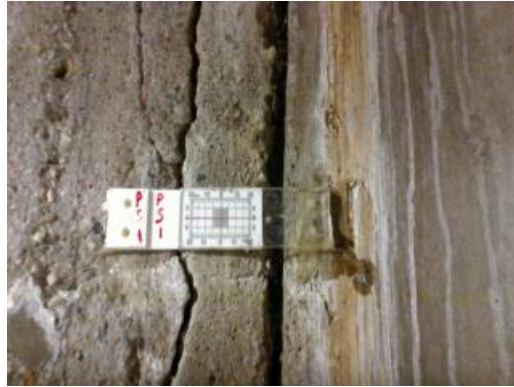
Moving Walls

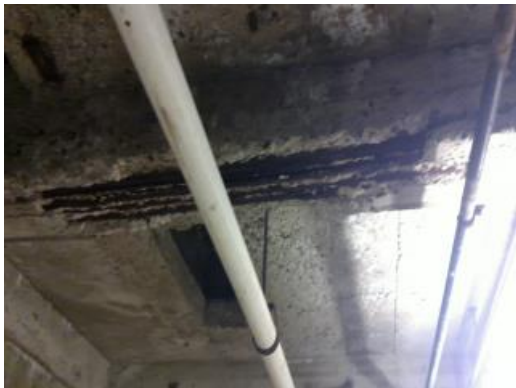
Deficiency	Category	Qty	UoM	Priority	Repair Cost	ID
Major Structural Condition Exists	Capital Renewal	1	Job	1	\$232,551	24671
Note: Water infiltration at window openings resulting in rusting of lintels and other steel members which expanded the steel causing the exterior brick and interior ceramic brick to crack and displace. Excessive moisture and lack of proper ventilation in basement area under the swimming pool is most likely the cause for the deterioration of the concrete. It is recommended that the following general remedial actions be taken: Remove existing steel lintels that exhibit excessive rusting or deterioration and replace with new galvanized steel lintels; Replace deteriorated relieving angles and repoint exterior brick; Review existing plans and evaluate the necessity to provide vertical control joints in the exterior brick veneer at corner locations; Remove cracked ceramic masonry, repair any deteriorated steel and replace ceramic masonry; Remove all deteriorated concrete and reinforcing steel from pool basement beams and overhead slab and replace with new epoxy coated reinforcing of comparable size as original design and form with new concrete.

Rusted Rebar Exposed

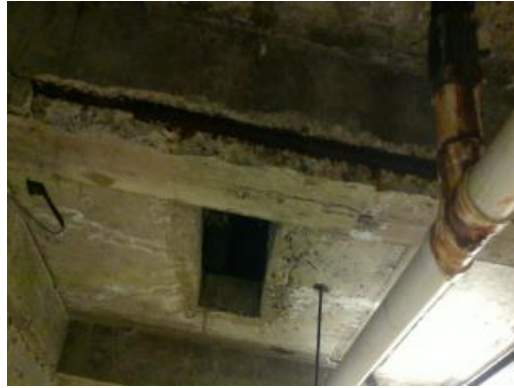
Shifting Walls

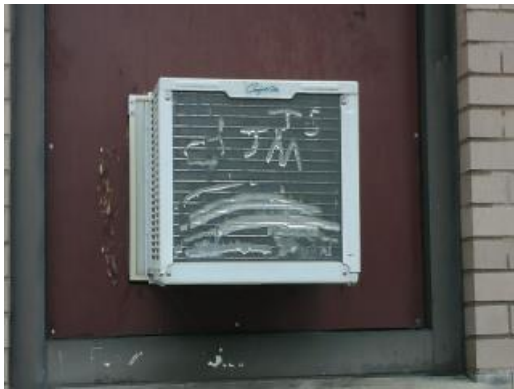
Aged Window Unit

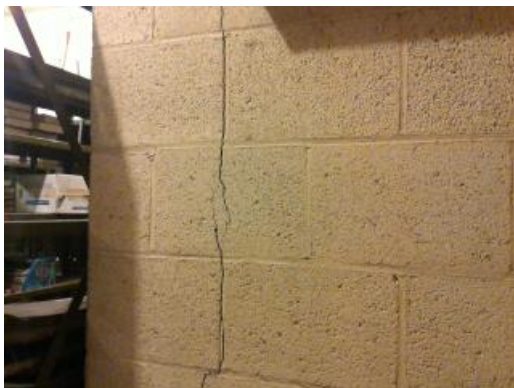
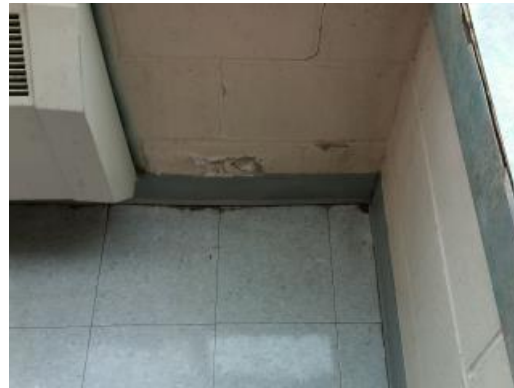
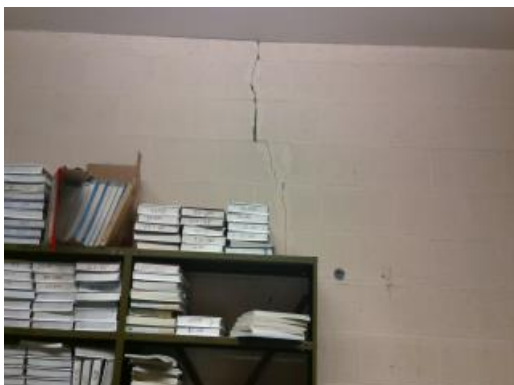
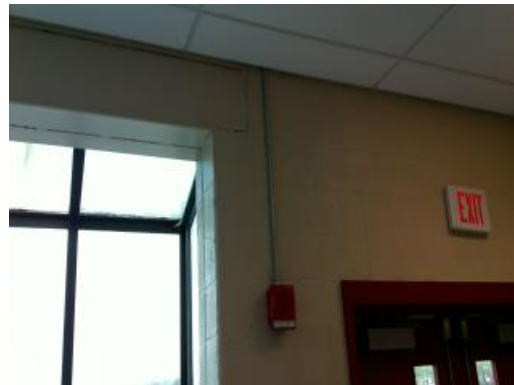
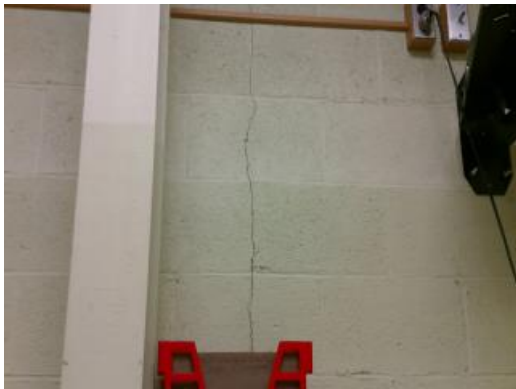
Deficiency	Category	Qty	UoM	Priority	Repair Cost	ID
Interior CMU Walls Require Repair	Capital Renewal	10,000	SF	3	\$382,907	11144
Location: Cafe, Room 149R, nurse's office, 3rd floor storage, teacher's lounge, 2nd floor storage						
Interior Doors Require Replacement	Capital Renewal	197	Door	3	\$957,719	11113
Note: Original 1952 interior wood doors.						
The Acoustical Ceiling Tiles Require Replacement	Functional Deficiency	19,113	SF	3	\$182,005	11110
Note: Original ceiling tiles should be replaced.						
The Acoustical Ceiling Tiles Require Replacement	Capital Renewal	500	SF	3	\$4,761	11111
Location: 3rd floor corridor						
The Acoustical Ceiling Tiles Require Replacement	Capital Renewal	5,395	SF	3	\$51,374	53564
Note: Per LEA review feedback cafeteria ceiling must be replaced (transition old to new).						
The Carpet Flooring Requires Replacement	Capital Renewal	5,205	SF	3	\$119,397	11114
Location: Library and auditorium

Cracked CMU

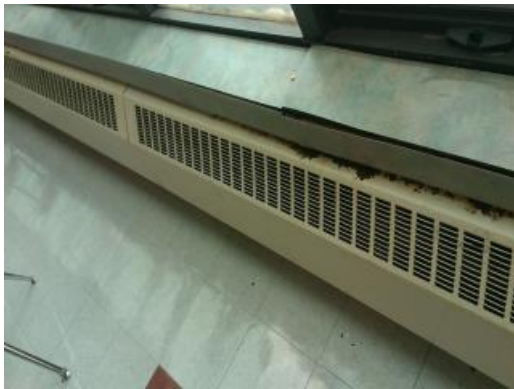
Rusted Finned Tube Radiator

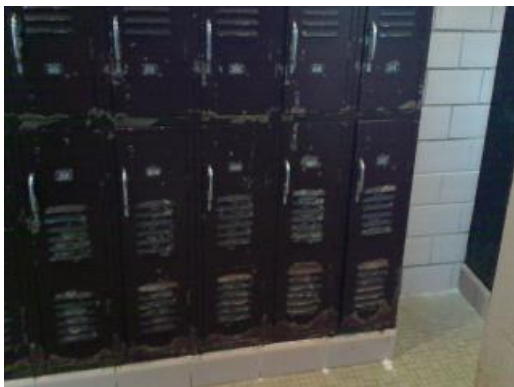
Aged And Rusted Lockers

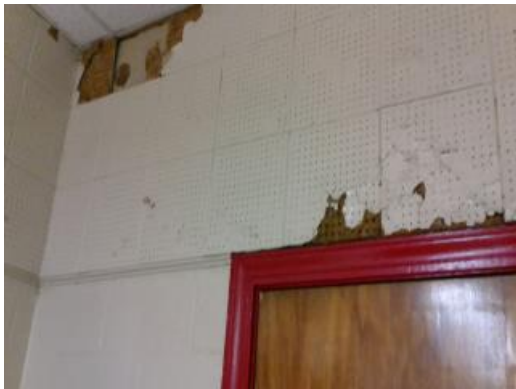
Broken Acoustic Wall Panel

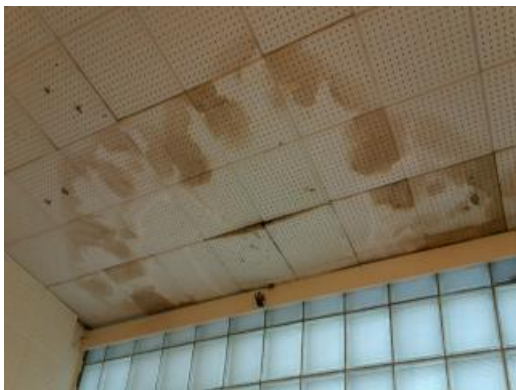
Deficiency	Category	Qty	UoM	Priority	Repair Cost	ID
Ceiling Grid Requires Replacement	Functional Deficiency	19,113	SF	4	\$239,012	11166
Note: Original grid system should be replaced.						
Ceiling Grid Requires Replacement	Capital Renewal	5,395	SF	4	\$67,466	53565
Note: Per LEA review feedback cafeteria ceiling must be replaced (transition old to new).						
Interior Ceramic Walls Require Repair Or Replacement	Capital Renewal	2,500	SF Wall	4	\$70,166	11126
Location: Cafe and gym						
Interior Ceramic Walls Require Repair Or Replacement	Capital Renewal	7,351	SF	4	\$172,422	11170
Note: Large cracks in ceramic wall. Steel lintels are rusted.						
Interior Storefront Doors Require Replacement	Capital Renewal	1	Door	4	\$5,012	53558
Note: Per LEA review feedback the interior glass door at the end of the art wing corridor is not to code.						
Interior Toilet Partition Requires Repair	Functional Deficiency	48	Ea.	4	\$26,463	11125

Failing Grid System

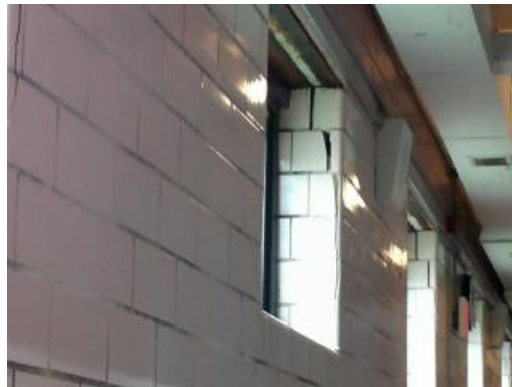
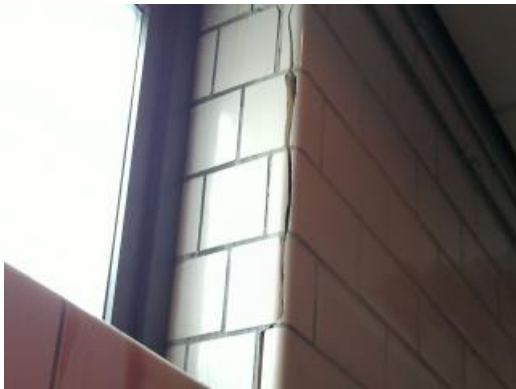
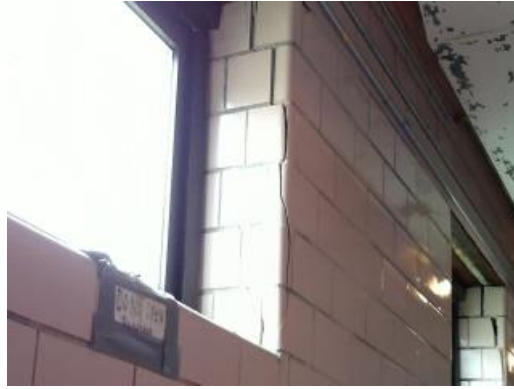
Cracked Tile Wall

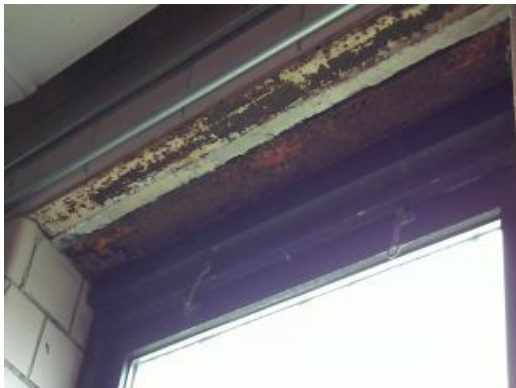
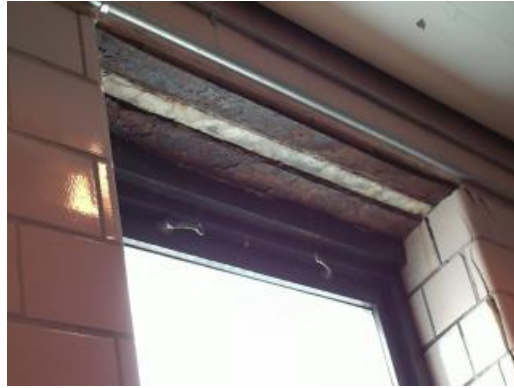
Rusted Steel Lintel

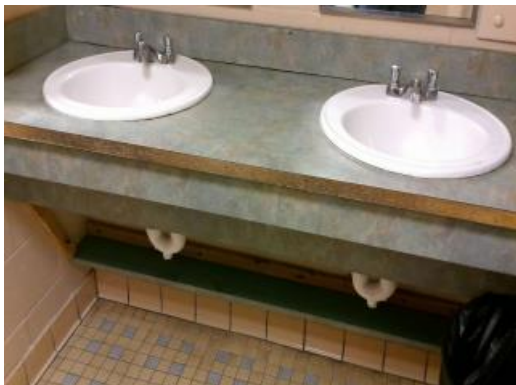
Damaged Countertop

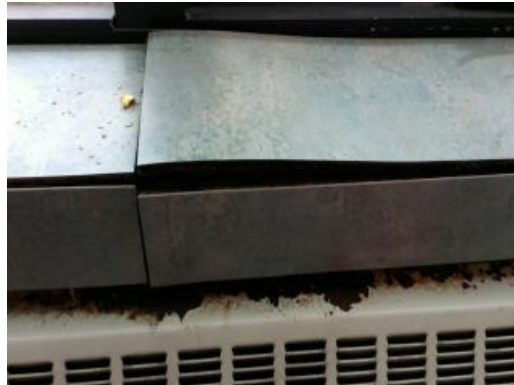
Delaminating Window Ledge

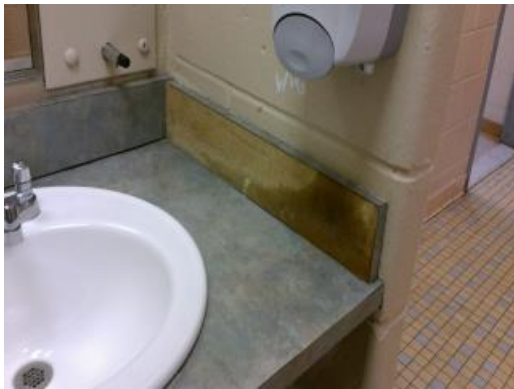
Delaminating Countertop

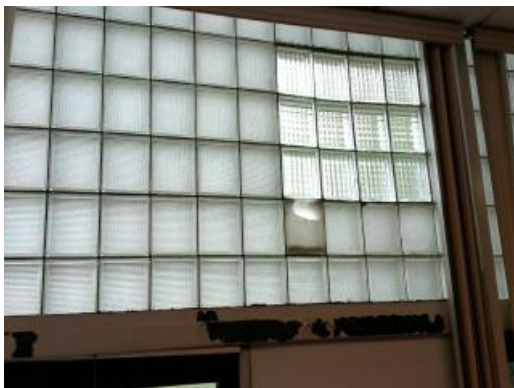
Deficiency	Category	Qty	UoM	Priority	Repair Cost	ID
Glass Block Requires Replacement	Functional Deficiency	14,279	SF	2	\$1,173,659	11174
Note: Glass block is aged and leaking.						
The Aluminum Storefront Exterior Door Requires Replacement	Functional Deficiency	1	Door	2	\$7,518	11105
Location: Door F						
The Aluminum Window Requires Replacement	Functional Deficiency	201	SF	2	\$35,863	11108
Note: Original windows in basement.						
The Aluminum Window Requires Replacement	Capital Renewal	500	SF	2	\$89,211	53562
Note: Per LEA review feedback the cafeteria atrium windows must be replaced.						
The Metal Exterior Door Requires Replacement	Functional Deficiency	3	Door	2	\$20,298	11104
Location: Doors 5, 12, 21						
The Overhead Door Requires Replacement	Capital Renewal	1	Door	2	\$38,792	11106
Location: Boiler room						
The Steel Window Requires Replacement	Capital Renewal	1,838	SF	2	\$414,532	11109
The Brick Exterior Requires Repair	Capital Renewal	12,500	SF Wall	3	\$877,078	11103

Leaking Glass Block Wall

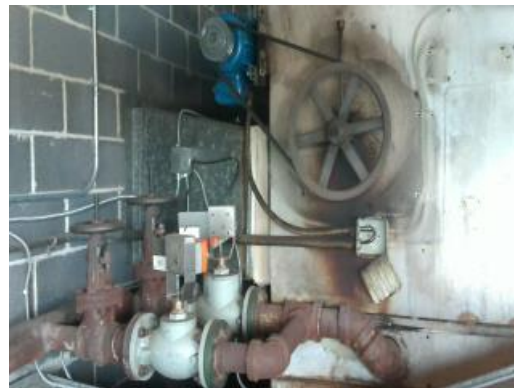
Failing Belt At AHU
